Manhole Inspection Summary

Manhole # S67I__003MH

Insp Date: **1/8/08 11:55 AM**

Location Address: **551 Dundalk Ave.**

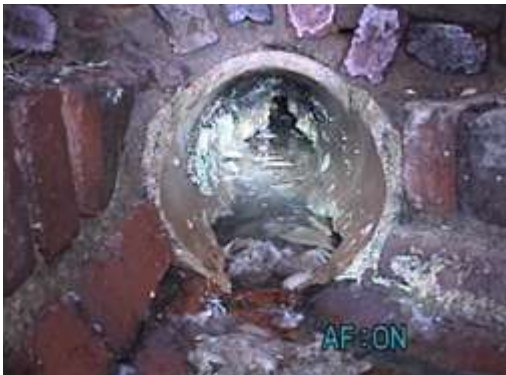
Defect 1

Comments **LOOKS LIKE 12-O PIPE IS FRACTURED VOID VISIBLE AT JUNCTION TO TROUGH. AFTER INSPECTING WITH CAMERA WE CONFIRMED THE BOTTOM OF THE CLAY PIPE IS BROKEN.**

Clay pipe cracked 4:00-7:00 void visible

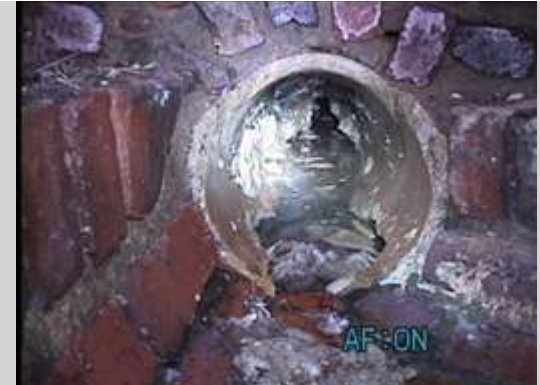
12 O'Clock Outflow

8 in. Circular Gravity Sewer
Pipe Out @ 12 O'Clock

Pipe Height: **8.4** (in.) Rod and Bar (Angled)
Pipe Material: **Clay** ☐ Pipe Lined
Invert Depth: **6.90** (ft.) Flow Characteristics: **Slow**
Deposits: ☐ None ☐ Mud ☐ Sludge ☒ **Debris** ☐ Grease
Silt Depth: **0.25** (in.) Deposits Extent: **Light**
Infiltration: **Weeper** Pipe Seal Cond: **Cracked**

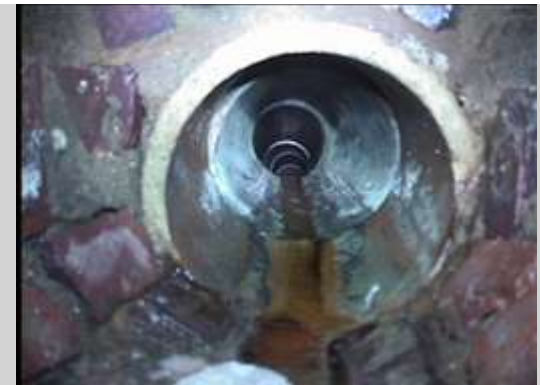
3 O'Clock Inflow

8 in. Circular Gravity Sewer
Pipe In @ 3 O'Clock

Pipe Height: **8.4** (in.) Rod and Bar (Angled)
Pipe Material: **Clay** ☐ Pipe Lined
Invert Depth: **6.70** (ft.) Flow Characteristics: **Slow**
Deposits: ☐ None ☐ Mud ☐ Sludge ☒ **Debris** ☐ Grease
Silt Depth: **0.25** (in.) Deposits Extent: **Light**
Infiltration: **None** Pipe Seal Cond: **Sound**

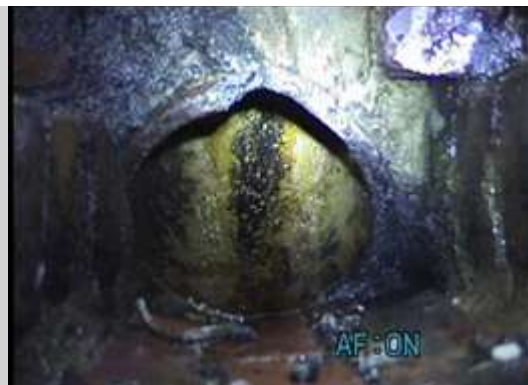
6 O'Clock Inflow

6 in. Circular Gravity Sewer
Pipe In @ 6 O'Clock

Pipe Seal Cond: **Broken**
